URGENT – DEVICE CORRECTION

RE: Olympus Mobile Workstations
Models WM-DP1, WM-NP1, WM-WP1 and WM-SC
Serial Numbers 2810808 and below

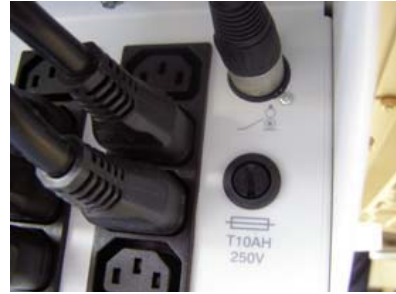
Fuse holder

Fuse carrier

3. Determine whether the fuse is appropriately secured by applying 0.5Nm force with a calibrated torque driver. If secure, there is no need to remove and inspect the fuse and fuse carrier as described in step 4.
4. If the fuse is loose, remove the fuse and inspect for any evidence of arcing or charring to either the fuse or fuse carrier. The pictures below illustrate a fuse carrier with and without charring. If no arcing or charring is present, insert the fuse back into the fuse holder and securely tighten it to 0.5 Nm. Use of a calibrated torque driver is required.
